MARINE CONSTRUCTION  
Project Highlight

**PROJECT:** Wax Lake Bulkhead Repair

**LOCATION:** St. Mary Parish

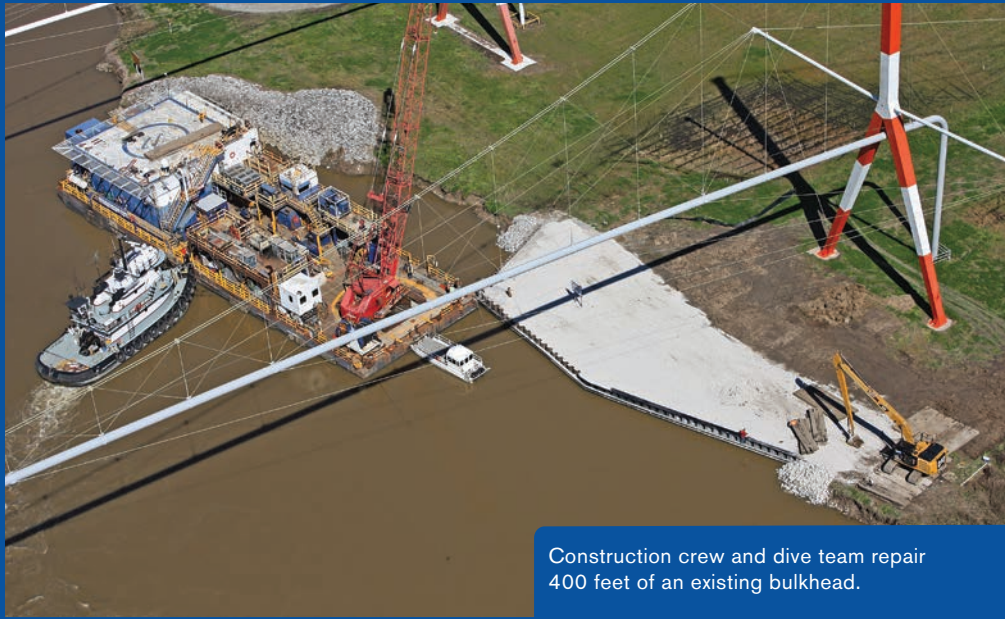
Construction crew and dive team repair 400 feet of an existing bulkhead.

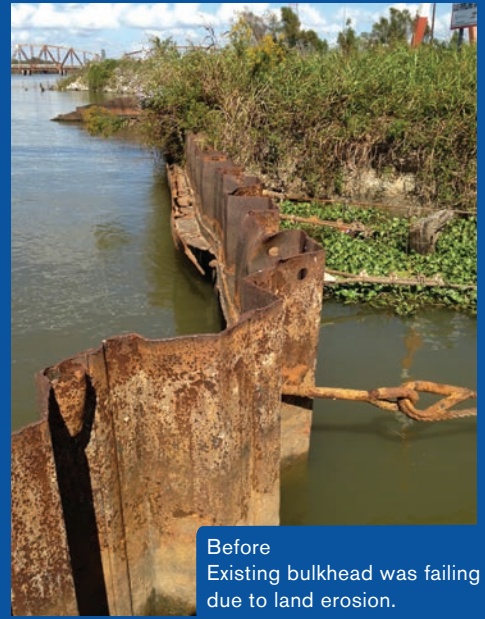
Before  
Existing bulkhead was failing due to land erosion.

- ▶ **The CM9 was selected for the project due to its anchoring ability.**
- ▶ **MORRISON divers facilitated underwater removal process to remove the collapsed portion of the underwater sheet pile wall that was potentially hazardous to navigation.**
- ▶ **The North and South wings of the East and West bulkheads were replaced.**
- ▶ **The area was backfilled with limestone from the new bulkhead to the existing coastline.**
- ▶ **The project was completed with zero recordables.**
